# INDOOR AIR QUALITY ASSESSMENT

# Garfield Magnet School 176 Garfield Ave Revere, MA 02151

Prepared by:
Massachusetts Department of Public Health
Center for Environmental Health
Emergency Response/Indoor Air Quality Program
November 2006

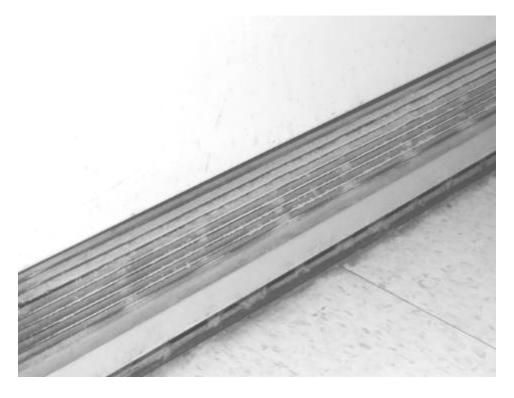
The exhaust vents are located on the walls at floor level (Picture 1). This design allows for the vents to be easily blocked by stored materials and occluded by floor dust.

**Exhaust Vents Located at the Base of Hallway Walls within Classrooms**

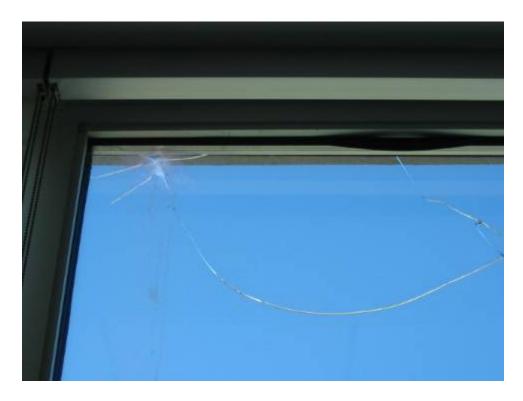
Picture 2

Air infiltration was noted around cracked or broken windows (Picture 2). In several rooms the window seals appeared to be failing (Picture 3). In addition, condensation was observed between window panes of several windows, further indicating that seals were no longer intact (Picture 4). Repairs of window leaks are necessary to prevent water penetration and drafts. Repeated water damage can result in mold colonization of window frames, curtains and items stored on or near windowsills.

**Crack in Window**

- 6. Repair broken windows and replace missing or damaged window caulking to prevent water penetration and drafts.
- 7. Ensure all plants are equipped with drip pans. Examine drip pans for mold growth and disinfect areas of water leaks with an appropriate antimicrobial where necessary.

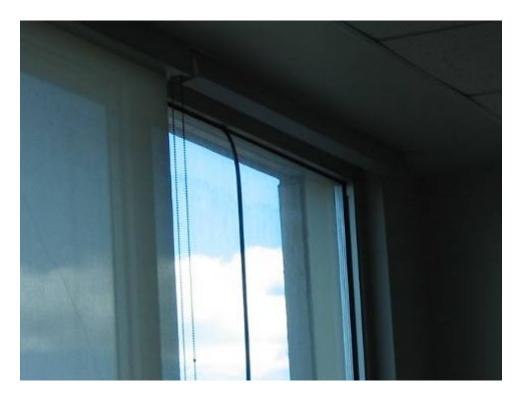
**Failing Rubber Gasket**

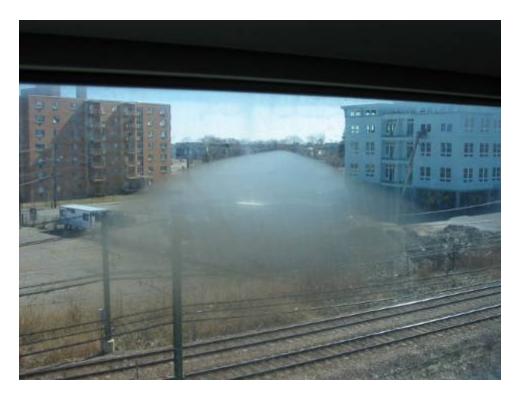
**Condensation between Window Panes**

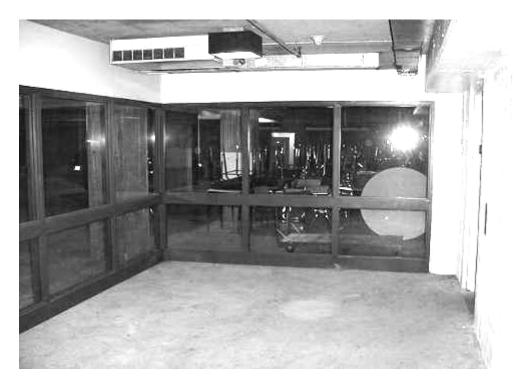
**Parking Lot Lobby**

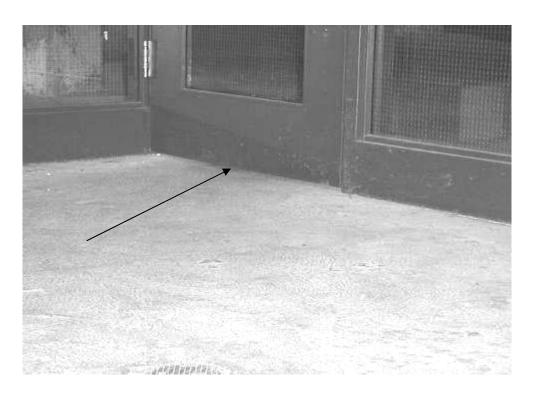
Space beneath Elevator Lobby Door in Parking Garage

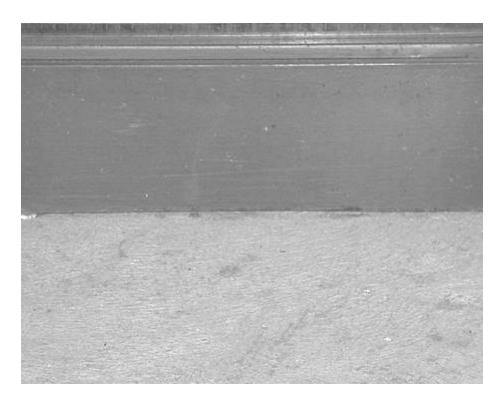
Seams between the Lobby Glass and Steel Walls and the Cement Floor

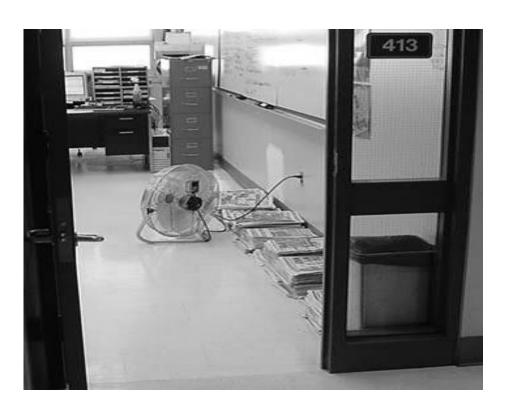
During the October 5, 2005 visit, a strong odor of newspaper ink was noted in the hallway outside of room 413. Within this room were several piles of newspapers stacked near the hallway door (Picture 8). A fan was placed next to the newspapers, which was drawing air from the hallway, over the newspapers. Newspapers are made from paper that is printed using a wet ink process. These inks frequently contain VOCs, which off-gas from the paper over time. These VOCs as well as other chemicals used to manufacture paper can be irritating to the eyes, nose, throat and respiratory system.

Newspapers Stacked Inside Classroom, Note Location and Position of Fan

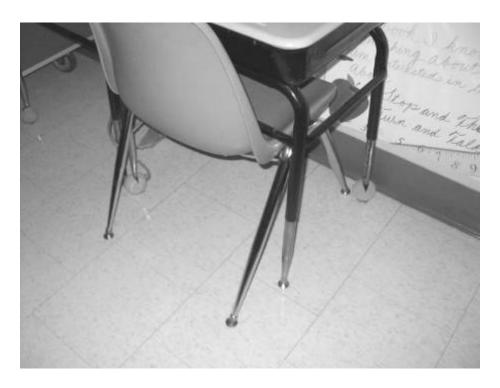
In an effort to reduce noise from sliding chairs, tennis balls had been sliced open and placed on chair legs (Picture 9). Tennis balls are made of a number of materials that are a source of respiratory irritants. Constant wearing of tennis balls can produce fibers and off-gas TVOCs. Tennis balls are made with a natural rubber latex bladder, which

becomes abraded when used as a chair leg pad. Use of tennis balls in this manner may introduce latex dust into the school environment. Some individuals are highly allergic to latex (e.g., spina bifida patients) (SBAA, 2001). It is recommended that the use of materials containing latex be limited in buildings to reduce the likelihood of symptoms in sensitive individuals (NIOSH, 1998; NIOSH, 1997).

**Tennis Balls Sliced Open and Placed on Chair Legs**

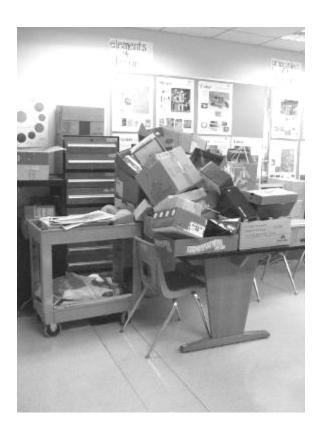
Finally, was the amount of materials stored inside classrooms (Picture 10). In classrooms throughout the school, items were observed on windowsills, tabletops, counters, bookcases and desks. The large number of items stored in classrooms provides a source for dusts to accumulate. These items, (e.g., papers, folders, boxes) make it difficult for custodial staff to clean. Dust can be irritating to eyes, nose and respiratory tract. Items should be relocated and/or be cleaned periodically to avoid excessive dust build up.

**Accumulated Materials Stored inside Classrooms**

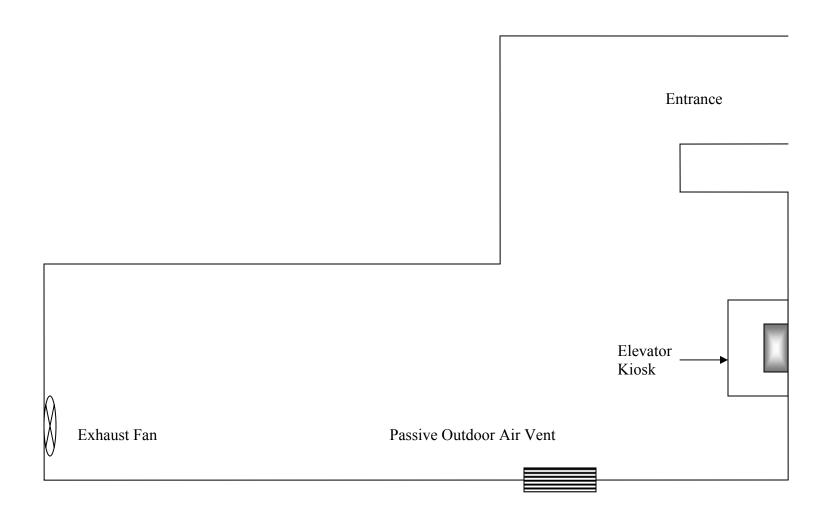
Figure 2
General Configuration of Underground Parking Garage

These concentrations appear to be related to the presence of an underground parking garage located beneath the GMS. The parking garage is in the shape of a zigzag (Figure 2), with the elevator lobby at the east end of the lot (Picture 5). A mechanical exhaust system exists in the west wall of the parking garage. The exhaust system draws outside air from a passive air vent in the south wall of the parking garage. A passive outdoor air vent exists in-between the elevator lobby and the exhaust fan (Figure 3). In

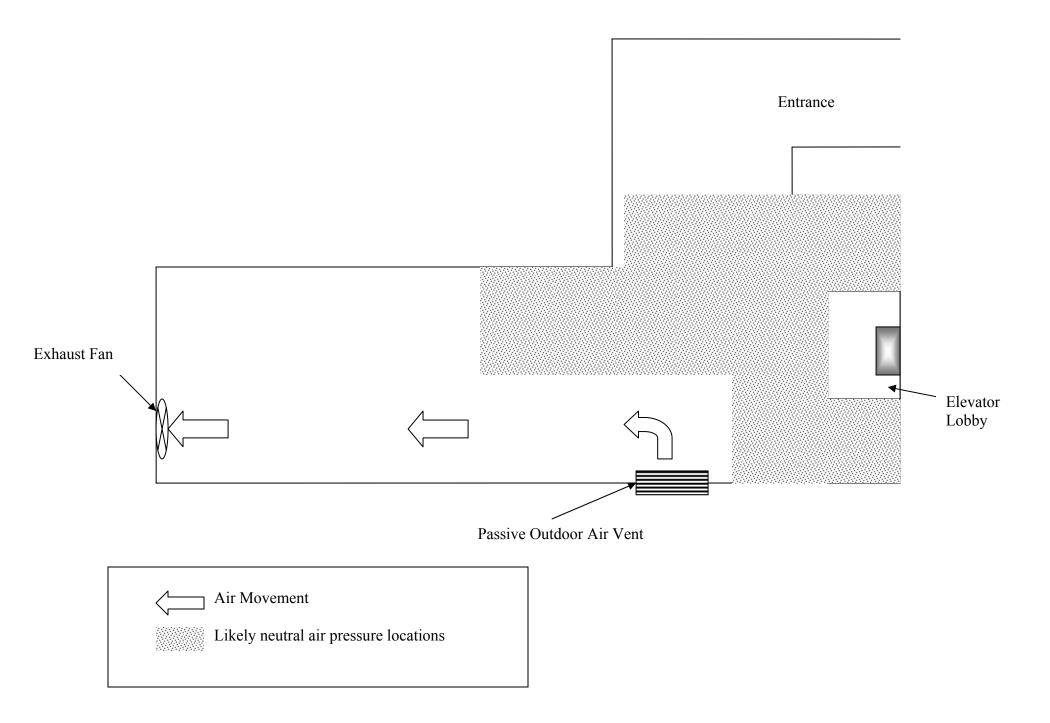
Figure 3
General Location of Pooling Air around Elevator Lobby

this configuration, it is likely that air and products of combustion from vehicles pool around the elevator lobby. Since the elevator creates the draw of air resulting from heated air rising up the elevator shaft (called the stack effect) and/or the piston-like action of movement by the elevator car, it is likely that the elevator lobby in the parking garage is depressurized. Depressurization will draw air and pollutants from the parking garage when the lobby door is open, through the space under the door (Picture 6) and/or through open seams that exist in the lobby walls and the cement floor (Picture 7). Products of combustion can be irritating to the eyes, nose and throat and should be properly vented outdoors.
